OCEANS ONE ELEVATOR LOBBY FENESTRATION PROJECT

Project Summary #12 Reporting Period: 1.8.2018 thru 1.19.2018 City of Daytona Beach Shores Permit # 20171318 Prime Contractor: Flores- Hager & Associates Superintendent: Matt Coats

PROJECT LOCATION 3051 South Atlantic Avenue, Daytona Beach Shores, Florida, 32118

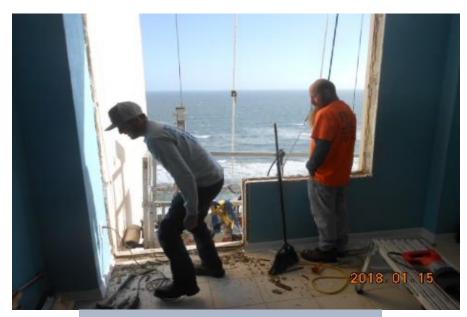
Sill repair work in progress at east guest bedroom window in Unit 2103

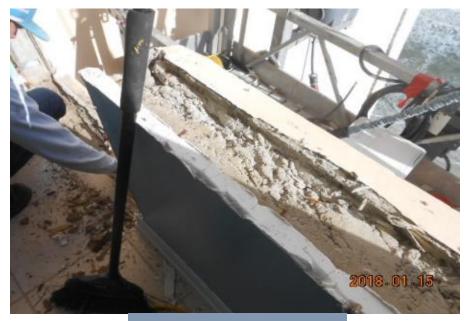
Original wet-set concrete at sill seen after window collapse in Unit 2103

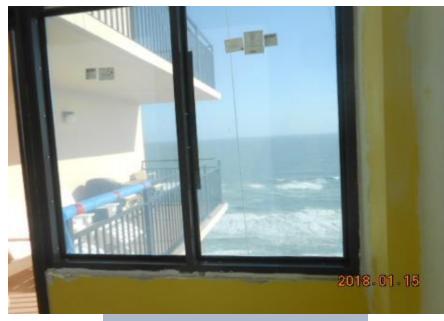
Window install at east living room window in Unit 2103

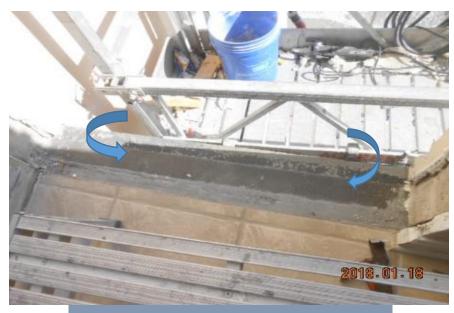
Photo shows recently cast sill at east guest bedroom window, Unit 2003

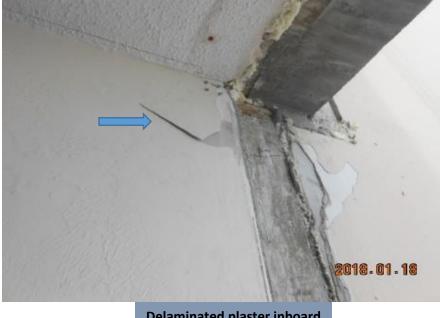
Delaminated plaster inboard of window opening, Unit 2103 guest bedroom

At the beginning of week two, window collapsing and sill repairs started at the 03 stack in the guest bedroom in Units 2003 and in the guest bedroom and east living room window in Unit 2103. Delaminated stucco repairs at the exterior and plaster finishes will soon follow in these Units inboard of the windows.

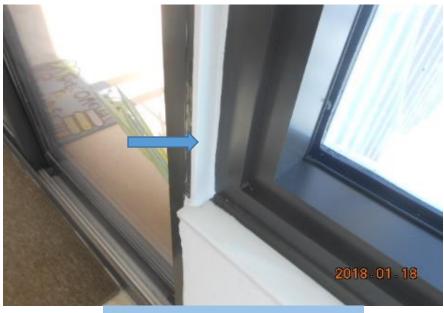
Lattice trim piece at window juncture
