# **OCEANS ONE ELEVATOR LOBBY FENESTRATION PROJECT**

Project Summary #9  
Reporting Period: 11.27.2017 thru 12.8.2017

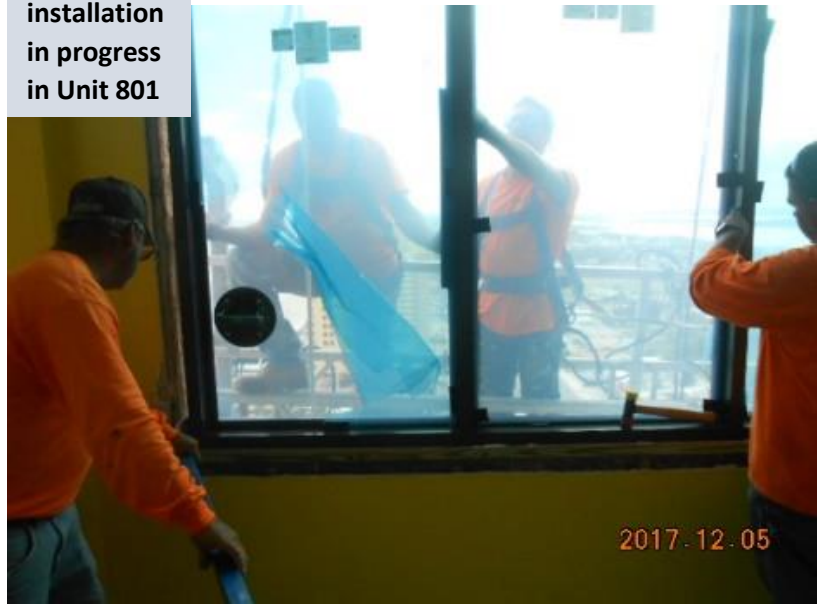
Window installation in progress in Unit 801

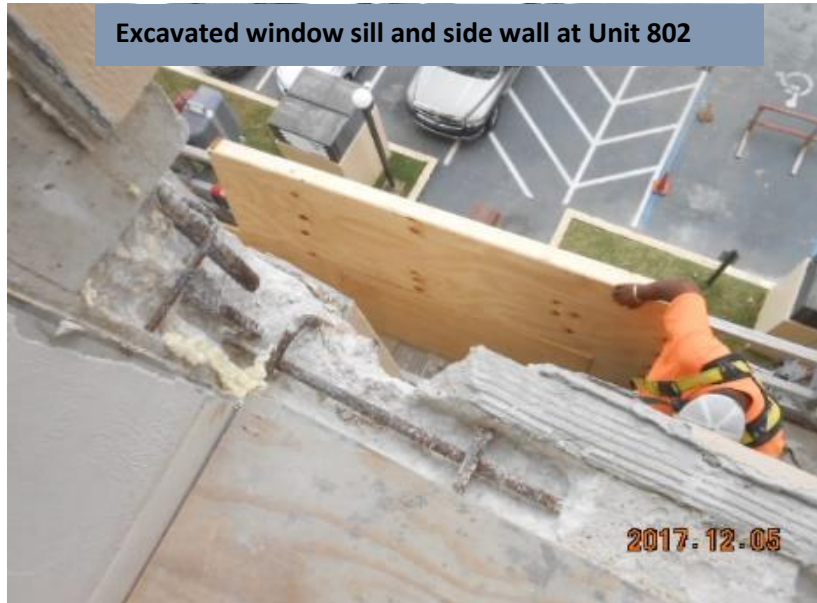
Excavated window sill and side wall at Unit 802

The engineer directed the crew's excavation efforts at the window sills where corroded reinforcing steel and distressed concrete was discovered with all repair efforts monitored by the engineer to ensure they follow the ACI and ICRI standards. The number of concrete sill repairs have increased since the beginning of the project, which and has required the engineer to move ahead with a Record of Repair that lists all the concrete repairs completed so far on the project.

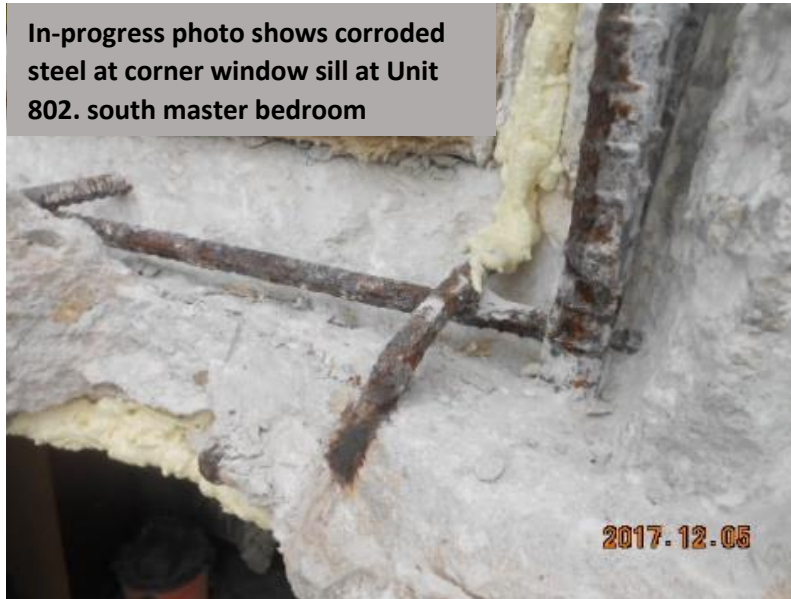
**In-progress photo shows corroded steel at corner window sill at Unit 802. south master bedroom**

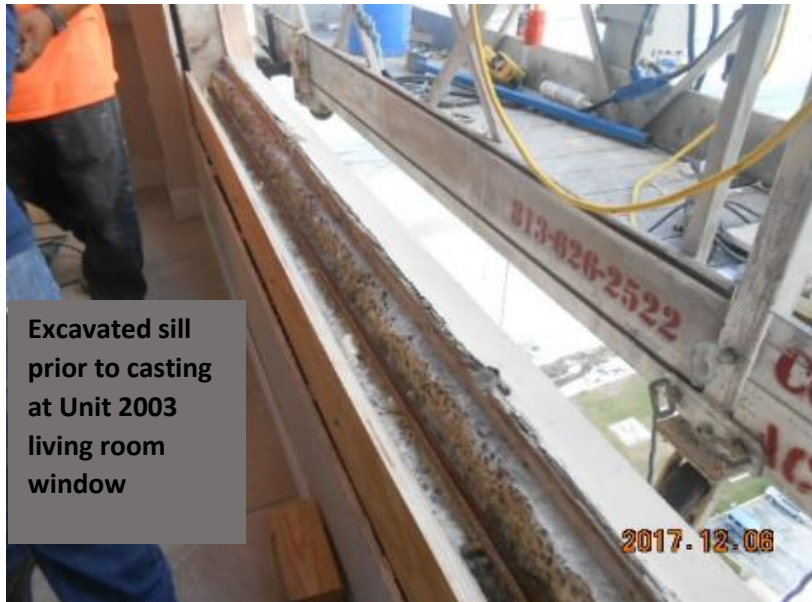
**Excavated sill prior to casting at Unit 2003 living room window**
