# **OCEANS ONE FENESTRATION PROJECT**

## **Flores-Hager & Associates Keystone Engineering and Consulting Project Summary # 1 July 31<sup>st</sup> through August 18<sup>th</sup>, 2017 City of Daytona Beach Shores Permit # 20171318**

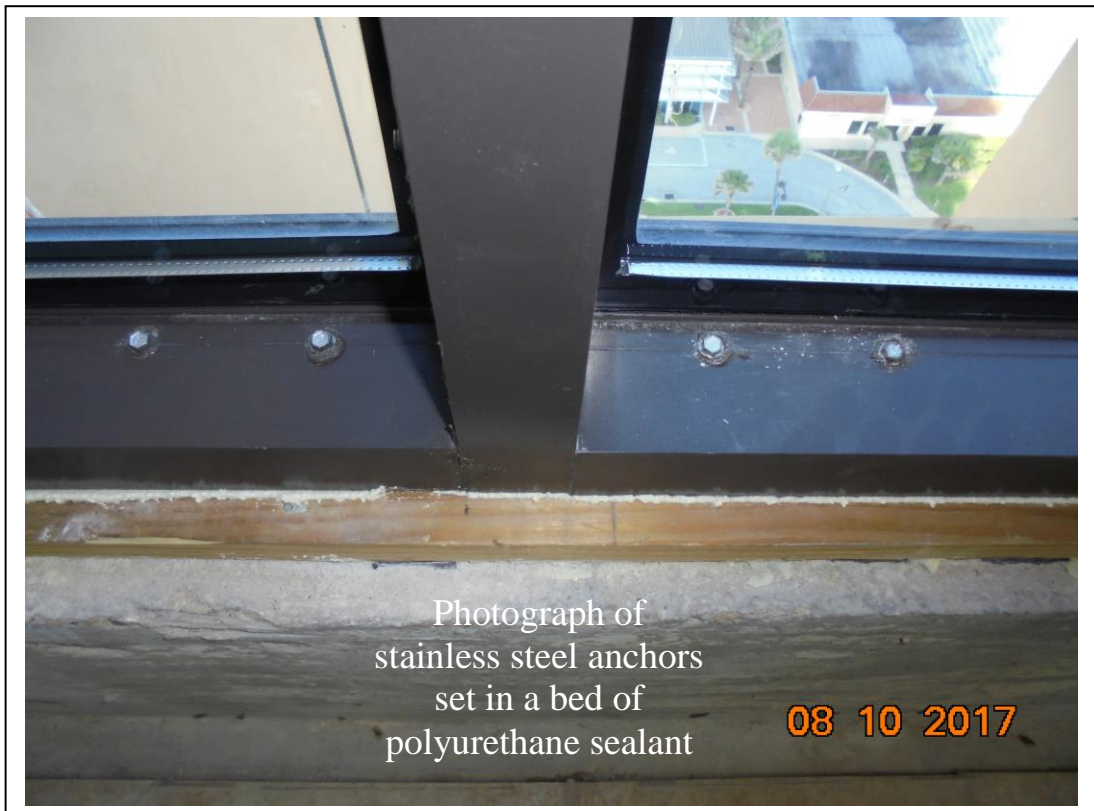
Arrows point to structural shims placed at each anchorage location

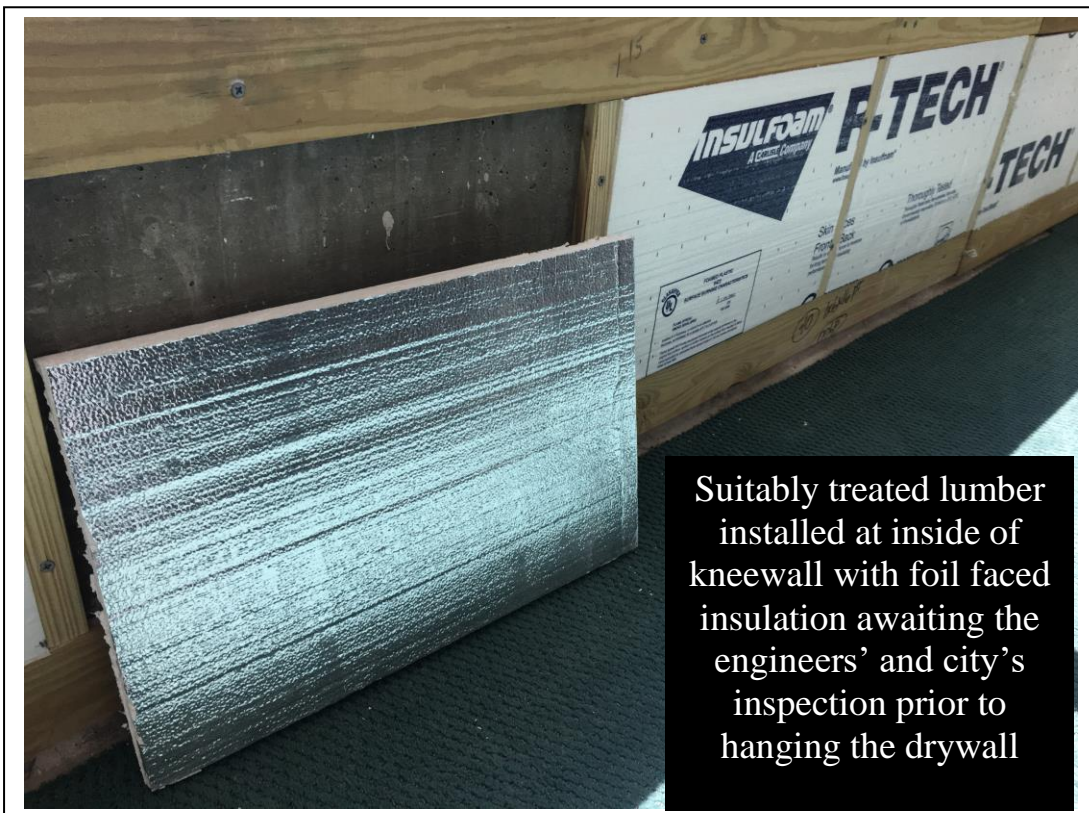
Suitably treated lumber installed at inside of kneewall with foil faced insulation awaiting the engineers' and city's inspection prior to hanging the drywall

Interior finishes kicked off during the week of August 14<sup>th</sup> with pressure treated furring strips being installed at the 21<sup>st</sup> and 22<sup>nd</sup> floor followed by installation of the ¾” foil-faced insulation. The popcorn texture adjacent to the installed fenestrations has also got underway with the base coat ready for “shooting” the texture on August 21, 2017 that will be experimented with until a satisfactory blend with the adjacent surfaces is achieved.
