## OCEANS ONE ELEVATOR LOBBY FENESTRATION PROJECT

Project Summary #16 Reporting Period: 3.5.2018 thru 3.16.2018 City of Daytona Beach Shores Permit # 20171318 Prime Contractor: Flores-Hager & Associates Superintendent: Matt Coats

PROJECT LOCATION 3051 South Atlantic Avenue, Daytona Beach Shores, Florida 32118

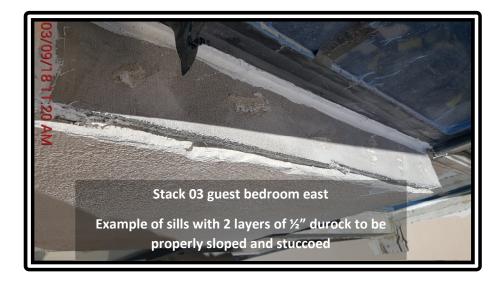
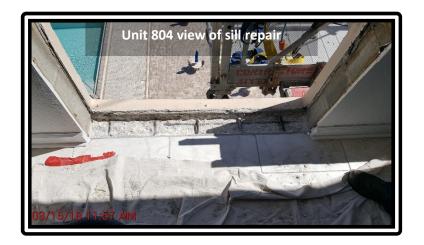
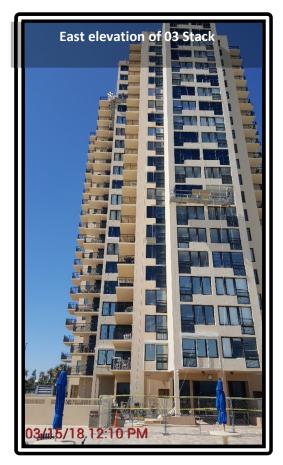
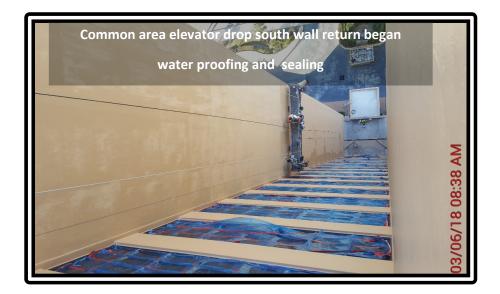
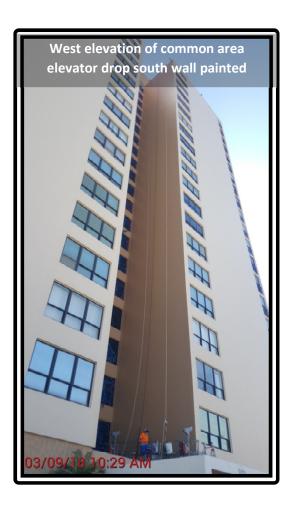
The crew focused their efforts on the window installations at the 03 and 04 stack. The east facing guest bedroom windows of unit 703, and the east master bedroom of units 1103, 1003, 1204, 603, 503, 2203, 803, 804 were completed.

Plaster matching and painting at the interior walls quickly followed. On the exterior, crew members made progress in a downward direction from two swing stages to apply the stucco and the first coat of Sherwin Williams' primer to the window installation return walls and sills.

The current living room still stucco slopes have 3 to 4 layers of cementious material to make up the slope needed for the windows. The layers include grout that was used to wet set the original windows, two layers of stucco scratch coat, and one final layer to get the correct 5 degree slope that makes for over a 2 inch sill height. Almost all units have demonstrated horizontal, vertical and even perpendicular cracks. Some were so deteriorated that they had to be removed. The 03 guest bedroom stack being the worst so far and it's costing great effort when finishing the exterior of the fenestrations. These sills will be replaced with 2 layers of  $\frac{1}{2}$ " durock with dymonic 100 flexible sealant between the layers. These layers will be fastened with 2.25" stainless steel tapcons. The correct sill slope will be made over top of these layers using stucco. Eight total sills were constructed on the 03 guest bedroom stack.

The washing and water proofing of the westerly facing common area elevator drop south wall return was completed. The wall had Sherwin Williams products applied to it including textured knife grade concrete patch, Modac acrylic texture coating, Loxon acrylic conditioner, and two coats of Superpaint which is a satin exterior paint and primer.
